## Site Inspection Report No. 01

**Week Ending:** 14th April 2023 (Week 2 of 28)  
**Inspection Date/Time:** 14th April 2023 / 08:30  
**Principal Contractor:** M. W. Benney

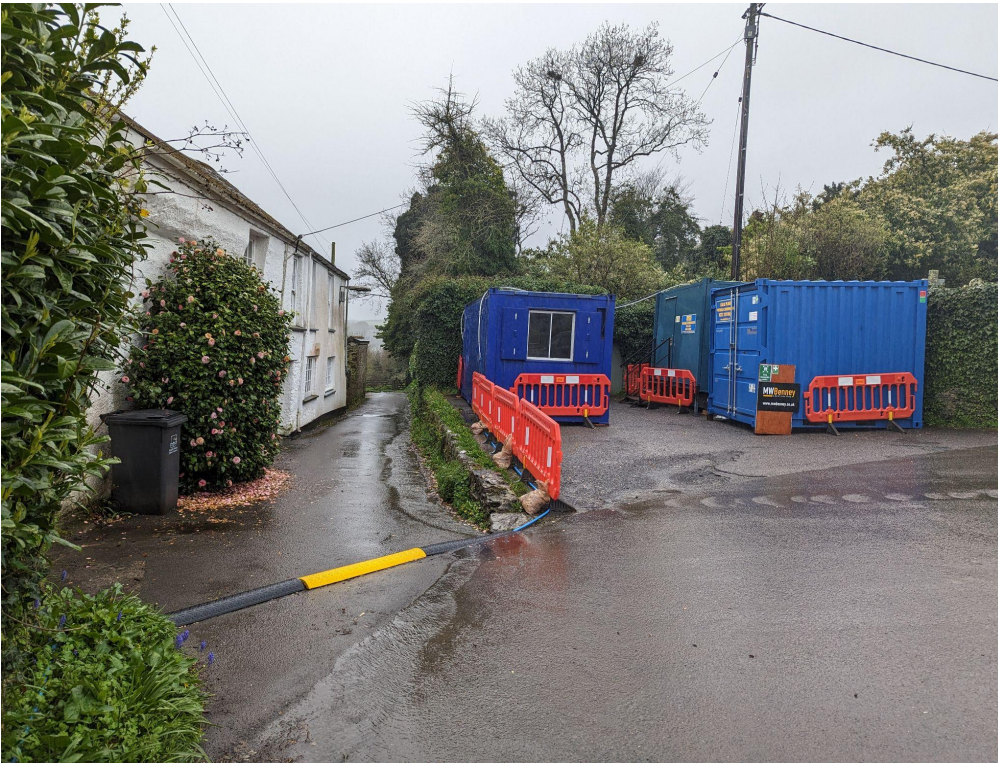
The project commenced on Wednesday 5th April 2023 and M. W. Benney (MWB) installed the site welfare facilities and erected Heras fencing in accordance with the Site Logistics Plan to segregate the works from the school. The welfare facilities provided are suitable for the type of work and number of operatives on site.

Photo 01 - Site welfare set-up.

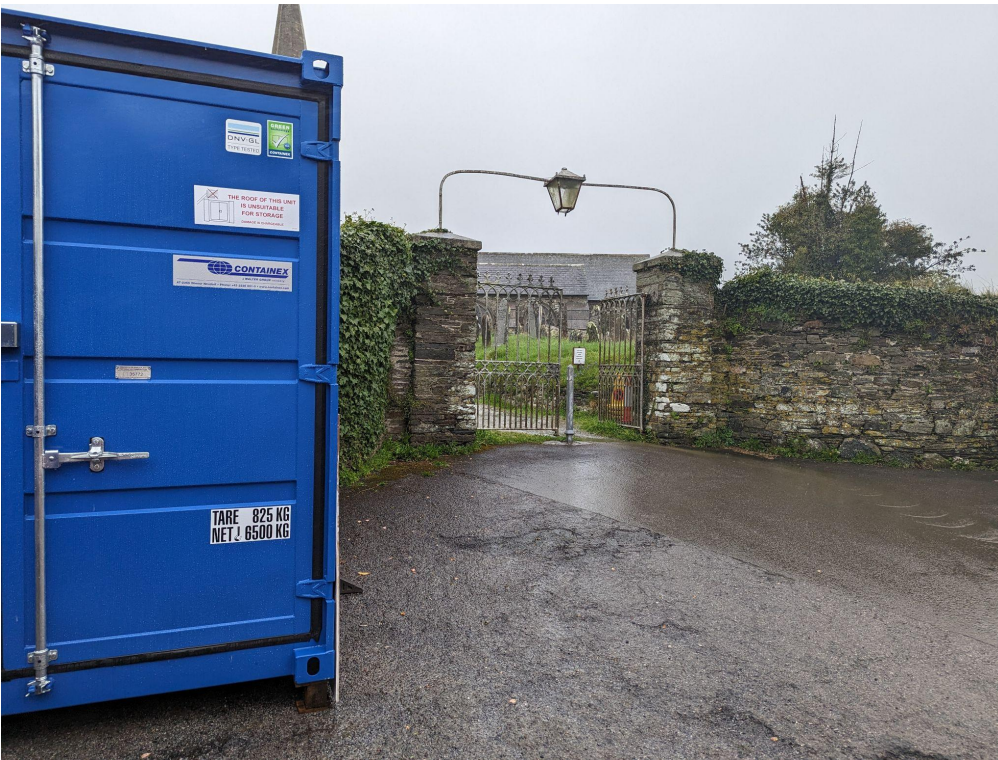
Photo 02 - Access maintained to local Church.

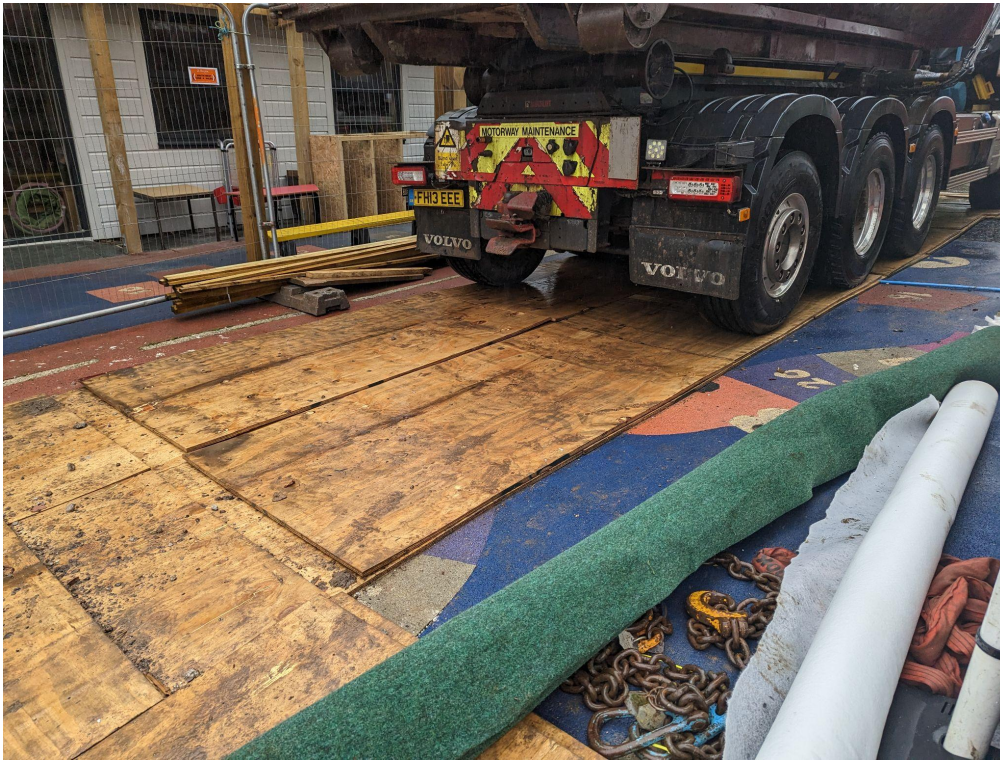
Photo 03 - Protection laid to rubberbound surface adjacent to Nursery.

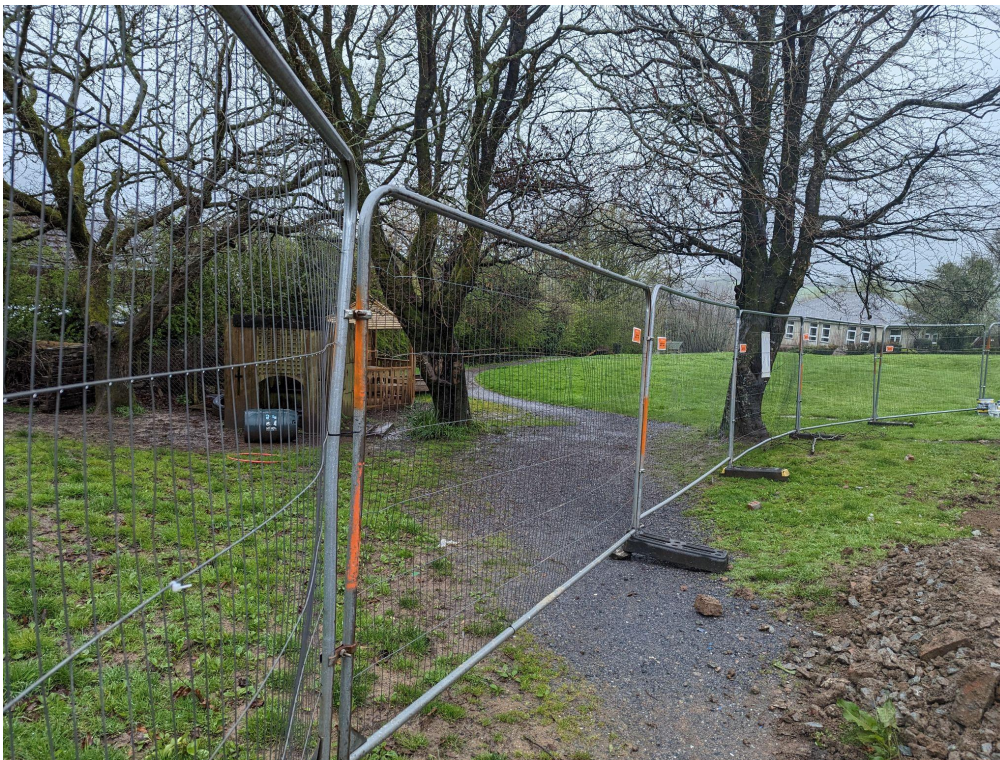
Photo 04 - Tree protection measures.

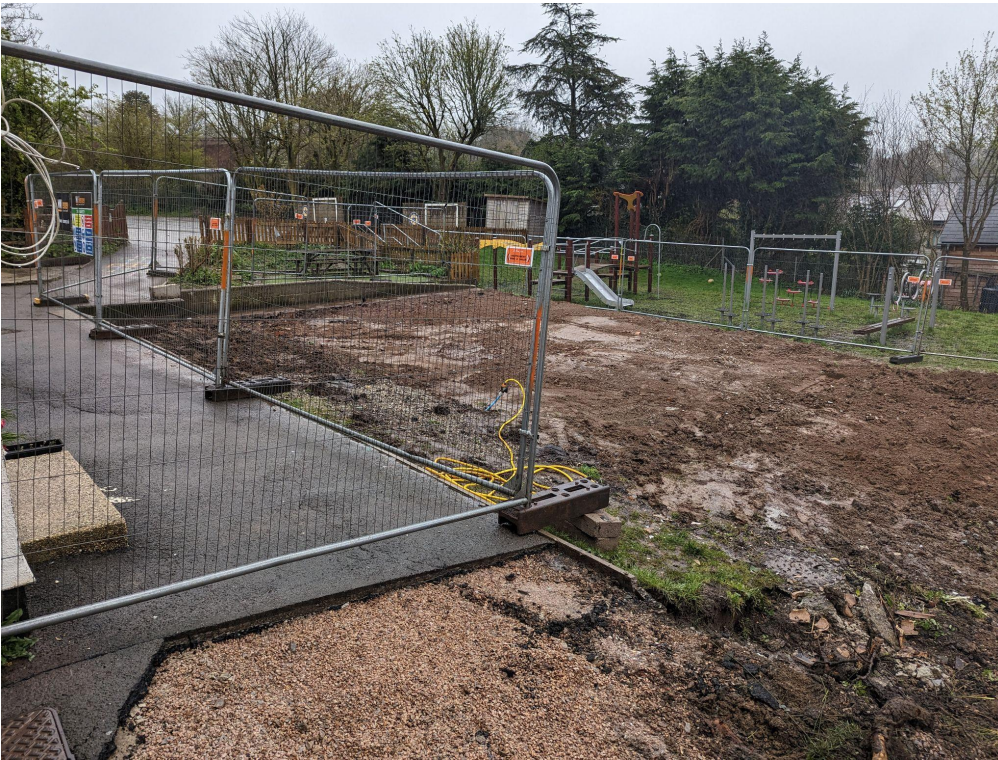
Photo 05 - Devon Lady Unit Nr1 demolished and material arisings carted from site.

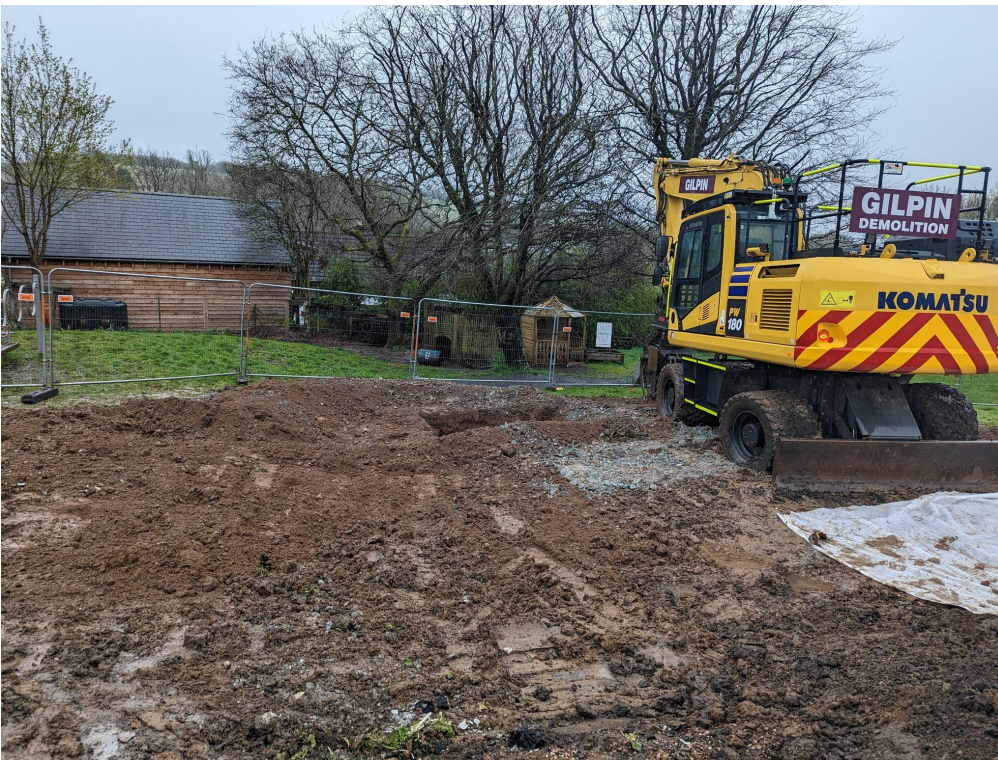
Photo 06 - Devon Lady Unit Nr2 demolished and material arisings carted from site.
